Sinkholes

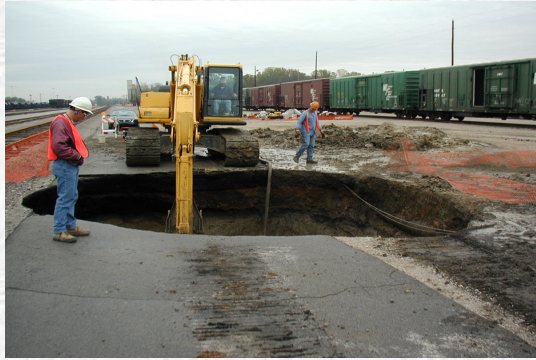
Sinkhole beneath railroad yard south of Birmingham, Alabama, 2000

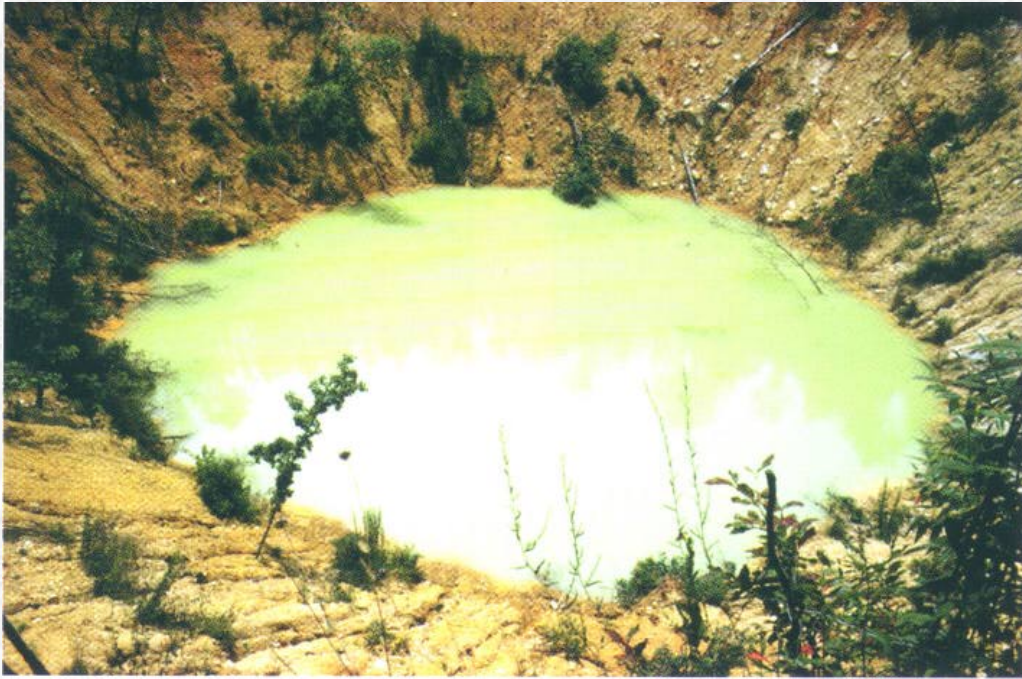
A large sinkhole (below) developed near Calera in Shelby County in a matter of seconds in December 1972. The sink is about 300 feet in diameter and 100 feet deep. This sinkhole occurred during a drought when the water table was much lower than normal.
